TECHNICAL REPORT REMR-CO-3

CASE HISTORIES OF CORPS BREAKWATER
AND JETTY STRUCTURES

Report 5

NORTH ATLANTIC DIVISION

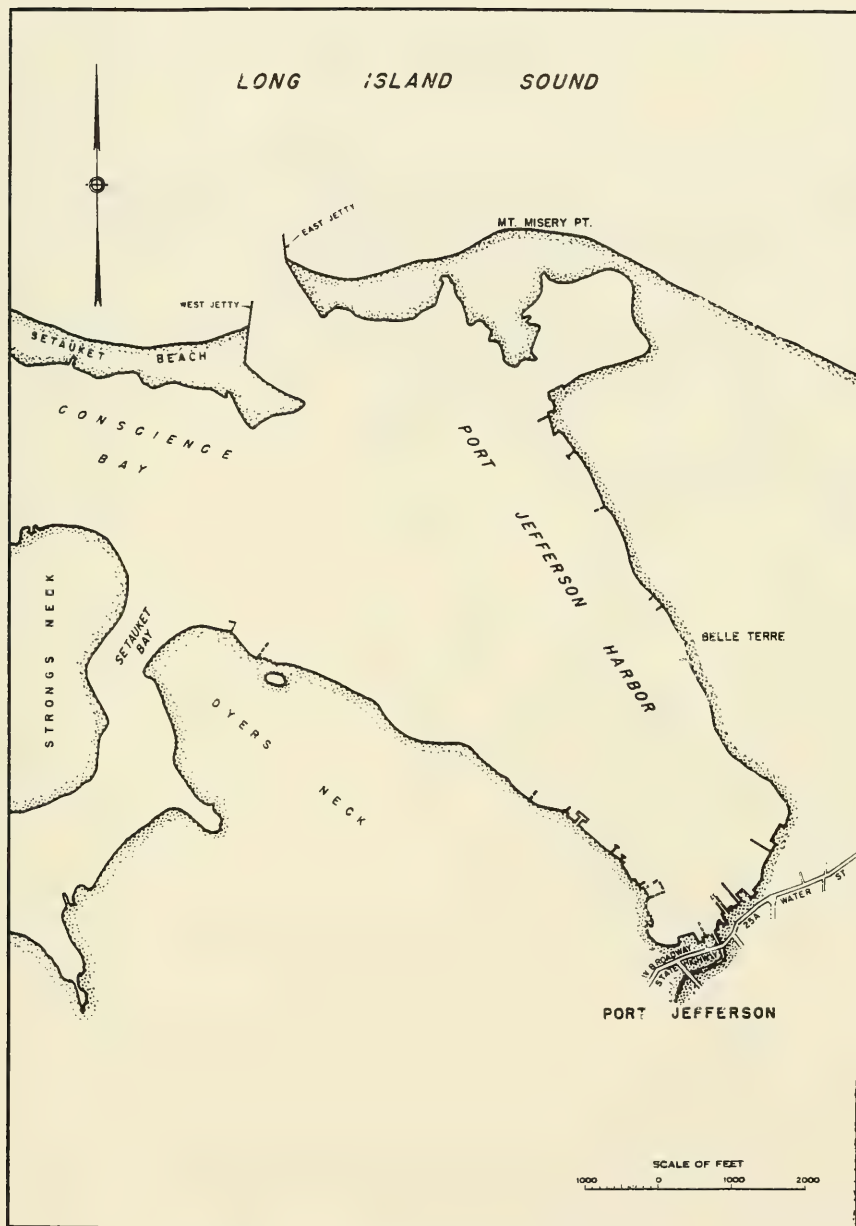
Figure 12. Port Jefferson Harbor, New York

1891	The east jetty was repaired over 600 ft with 1,464 tons of stone.
1908	The east jetty was extended to 1,550 ft (Figure 12).
1964	A survey indicated the jetties were in poor condition.
1986	No further repair or maintenance information has been found.

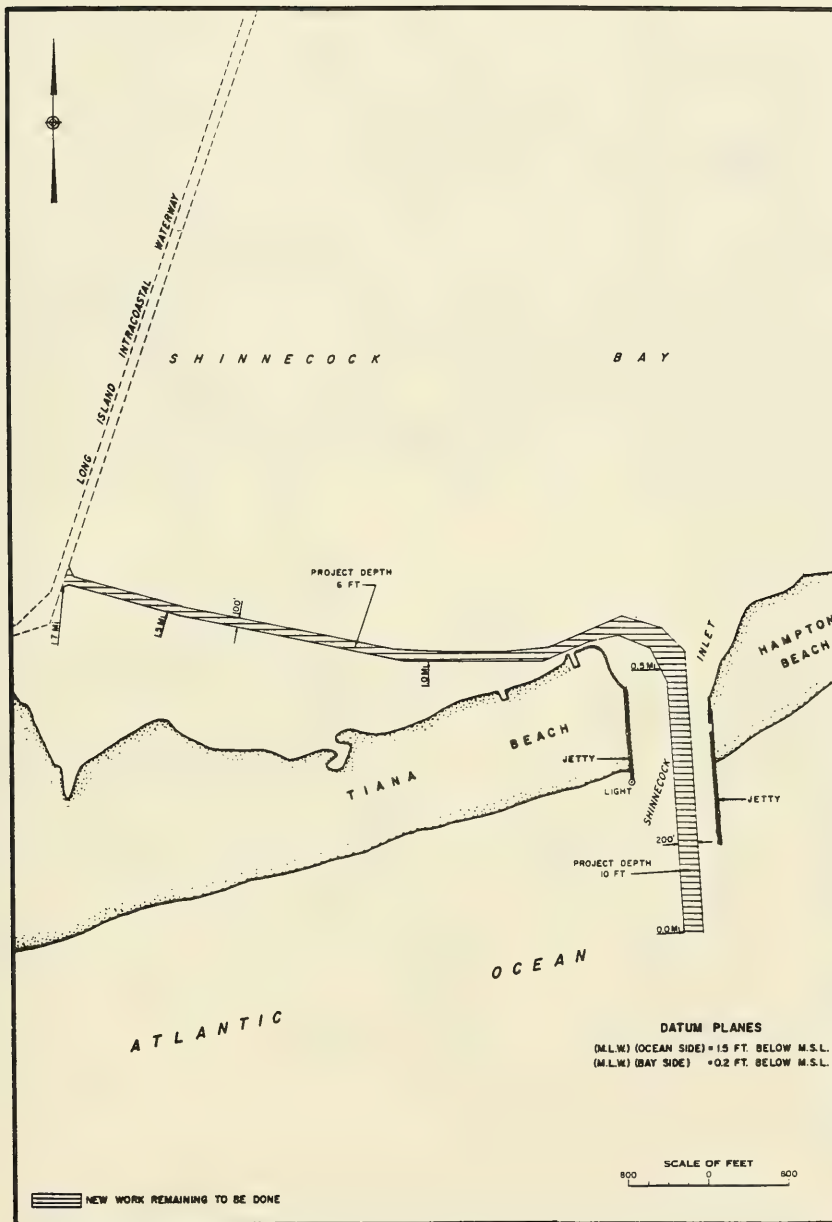
Figure 17. Shinnecock Inlet, New York

1956	A survey revealed that the east jetty had suffered severe damage. Capstones and slope stones had slipped and were disarranged in numerous spots. Core stones were washed out in several places. Capstones and core stones were washed out in four locations totaling 150 ft. The outer 250 ft of the jetty was partly washed out. Beach and dunes adjacent to the jetty eroded, and waves rode over the dunes and flanked the jetty. The west jetty was in fair condition with minor slips and disarrangement in five spots. The inlet was in a shoal condition. Most of the damage was due to a hurricane in 1954.
1982	The west jetty was reconstructed by resetting cap stones to original design geometry over 170 ft. A 1,470-ft-long pile crib revetment on the north end of the west jetty was replaced by a rubble-mound jetty. (Figure 18).
1985	A survey revealed that the reconstructed portion of the west jetty was in good condition. The seaward 200 ft of the west jetty had unraveled and capstones were scattered. The west jetty head had not maintained design configuration. Stones on the inlet side of the east jetty had sloughed in some sections, but stones on the beach side had retained their original position. Two areas on the northern end were completely deteriorated. Erosion of sand caused undermining of the east jetty with continual loss of sand undermining it further.

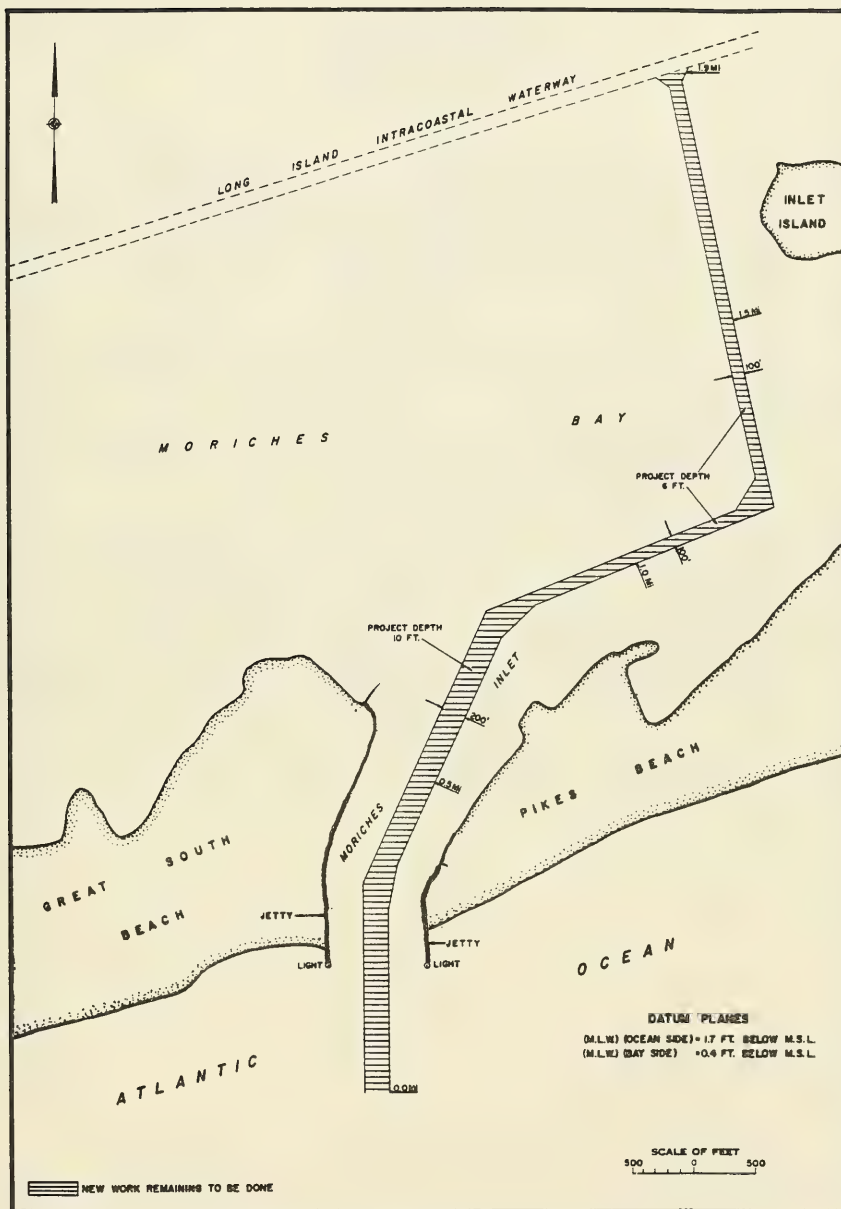
Figure 19. Moriches Inlet, New York

1954	Local interests extended the jetties to 841 ft east and 1,461 ft west (Figure 19) using 6.0- to 12.0-ton capstone at 1V:2H side slopes. Core stone used was 15 lb to 5.0 ton, east jetty, and 10 lb to 2.0 tons west jetty. A 2.0-ft-thick blanket and apron was placed using 15- to 500-lb stone. Jetty ends were approximately 800 ft apart. Cost was \$194,290 east and \$142,260 west.
1956	An inspection of the jetties was conducted. Stone on the inlet side of both jetties had slipped at numerous locations. Slope stones and capstones had unraveled at the outer end of the east jetty. Approximately 300 ft of the west jetty had settled 2.0 to 3.0 ft. The jetties had undergone severe wave attack since their construction, and most of the damage was attributed to the hurricane of August 31, 1954.
1983	A survey indicated the jetties were in a good, stable condition. The jetties had settled approximately 2.0 ft over 65 ft on the east jetty and 130 ft on the west jetty. The jetties did not meet Corps of Engineers standards for armor stone layer thickness, weight, or elevation, and it was determined that it would be more economical to maintain the jetties on an annual basis than by rehabilitation. Potential damage was anticipated to increase.

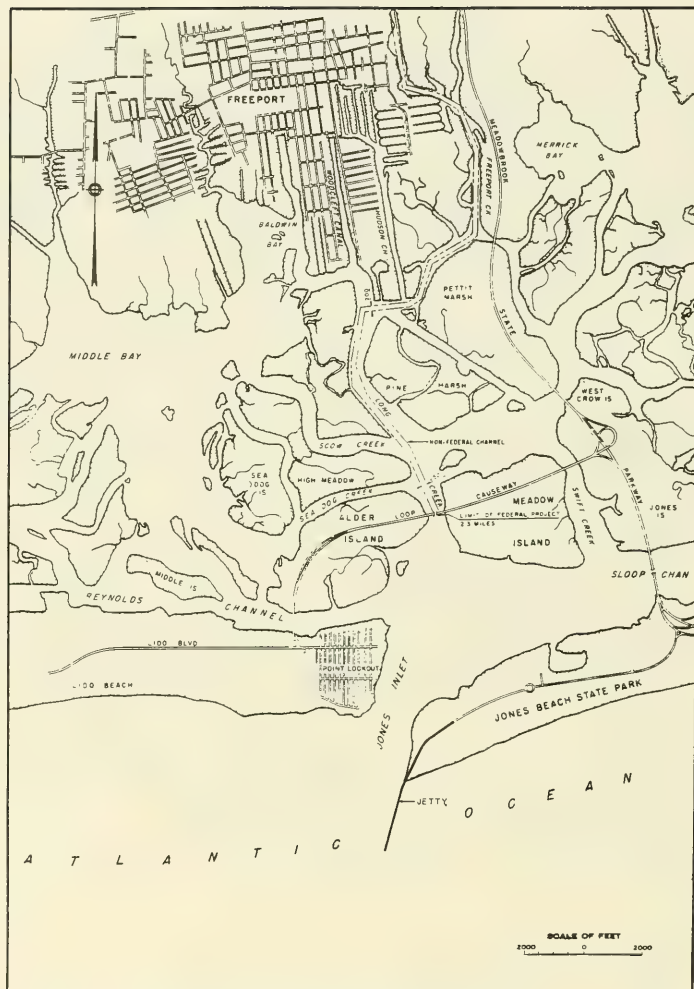
Figure 22. Jones Inlet, New York

1962	The Middle Atlantic coastal storm of 6-8 March 1962 damaged the jetty. The outer 200 ft was raveled and broken down to the high water level. A second layer of capstone was added to the outer 120 ft to restore the original design. The adjacent 1,080 ft shoreward was repaired by replacing armor stone and by adding stone. Armor stone was replaced on the adjacent 900 ft shoreward.
1985	The jetty had nearly reached impoundment. Sand was bypassing the jetty, mostly through large voids at the jetty-shoreline intersection. The apron had settled approximately 7.0 ft at the seaward end due to sand loss through voids in the apron.
1986	No further repair or maintenance information has been found.

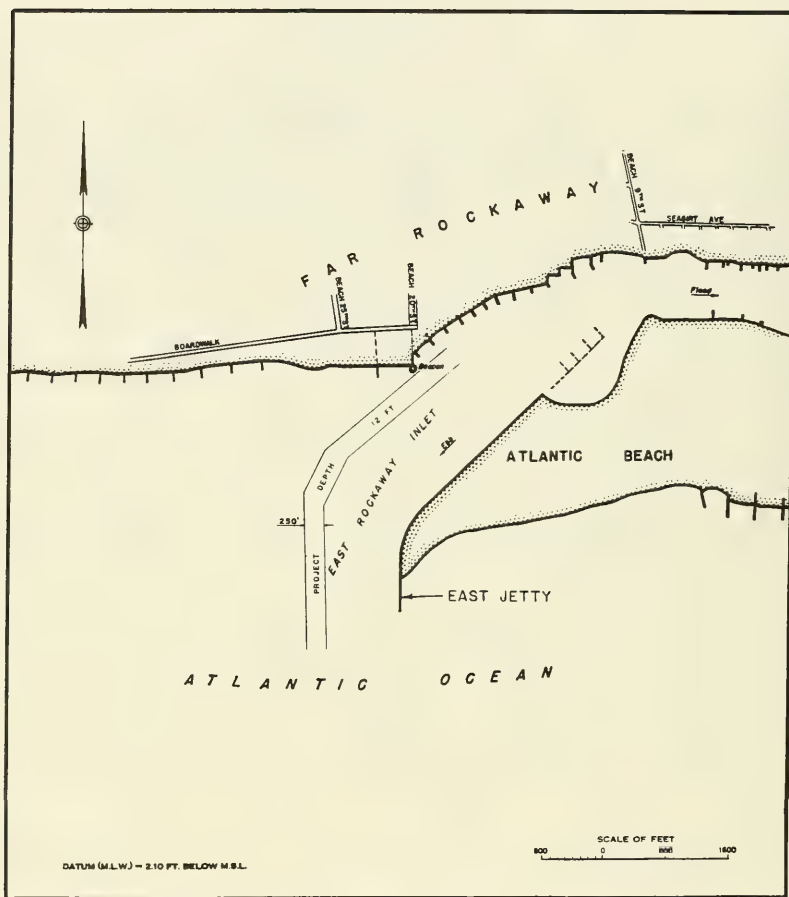
Figure 23. East Rockway (Debs) Inlet, New York

1941	Repairs were made by rearranging 212 tons of stone on the seaward 610 ft at a cost of \$6,000. An additional 375 tons were placed on the east side of the seaward end at a cost of \$1,670.
1946	Twenty-four hundred tons of stone were placed on the jetty at a cost of \$78,000. The jetty was considered to be in good condition.
1963	Repairs were made using 800 tons of stone at a cost of \$18,411, and the structure was in good condition with the exception of minor repairs.
1986	No further repair or maintenance information is available on the east jetty. The west jetty has not been built. The project has been deauthorized.

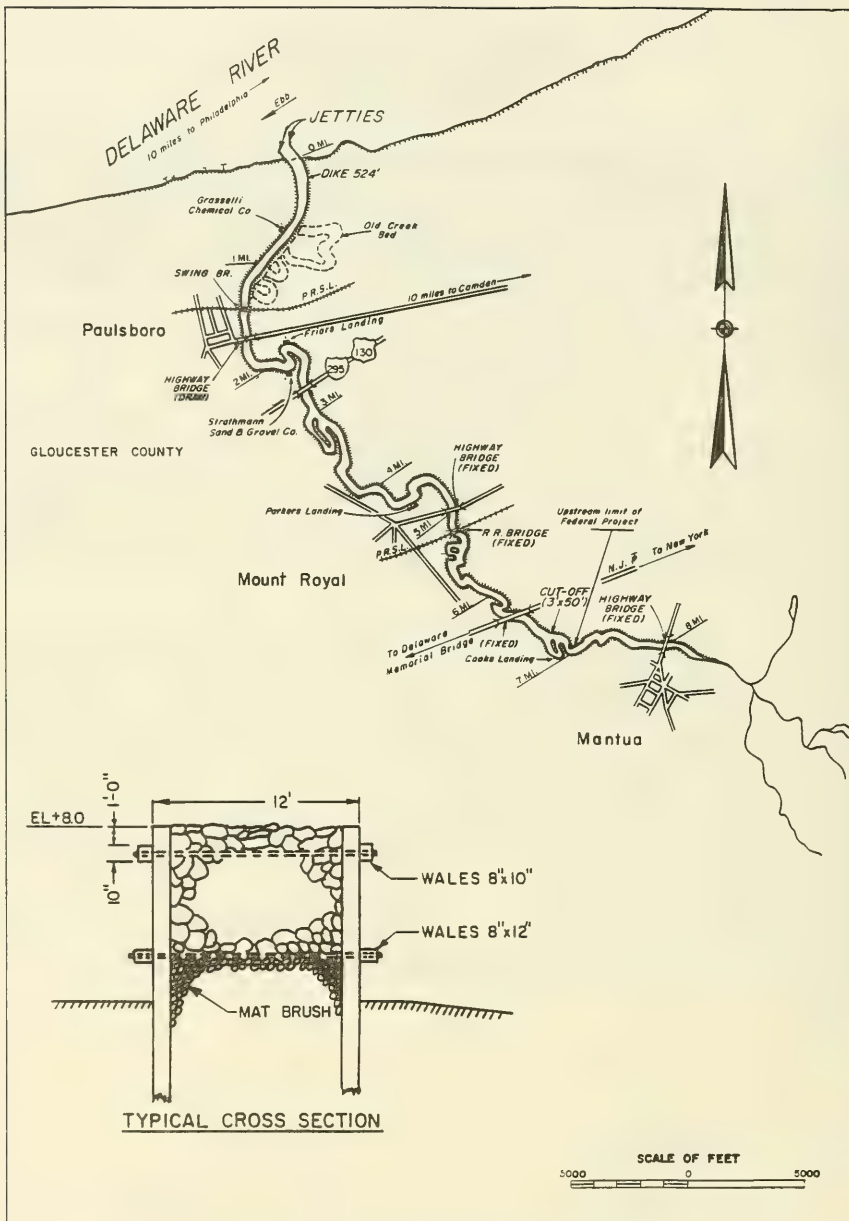
Figure 28. Mantua Creek, New Jersey

<u>Date(s)</u>	<u>Construction and Rehabilitation History</u>
1907	Two jetties were constructed to provide channel protection. Lengths were 754 ft and 580 ft east and west, respectively. The jetties were constructed of stone-filled timber cribs, with mat brush placed to support the stone (Figure 28). Top width and elevation were 12.0 ft and +8.0 ft mlw, respectively, for each jetty.
1912-1913	The east jetty was extended to 1,577 ft, and the west jetty was extended to 1,456 ft (Figure 28).
1918	Repairs were made by the addition of stone.
1962	An investigation of the jetties revealed the jetties had settled an average of 2.0 ft. Approximately 100 ft of the offshore end of the east jetty had deteriorated, with most of the pilings gone, and stone had fallen out to below the waterline. Most of the walings had deteriorated and were missing. Piles were missing at intermediate locations along the jetties, but there was no significant loss of stone at those locations. Piles that remained were in good condition.

1963	The jetties were rehabilitated at a cost of \$136,895. A new row of piles was placed over approximately 100 ft at the offshore ends. Piles were placed 7.5 ft on either side of the center line of the jetties. Corestone was dumped between the piles to an elevation of +8.0 ft mlw (Figure 29). Missing piles were replaced, and new wales were provided along the remainder of the jetties. One row of capstone was placed on the inner sides of both cribs on top of the existing stone to +8.0 ft mlw. Core stone was filled between the capstones in the center of the jetties to +8.0 ft mlw (Figure 29). Crown width was 16.0 ft at the offshore ends and 12.0 ft on the remainder of the jetty. Design wave height was 4.2 ft.
1964	Repairs were made to the seaward end of the east jetty at a cost of \$4,864. The Corps was reimbursed later for this work.
1986	No further repair or maintenance information has been found.

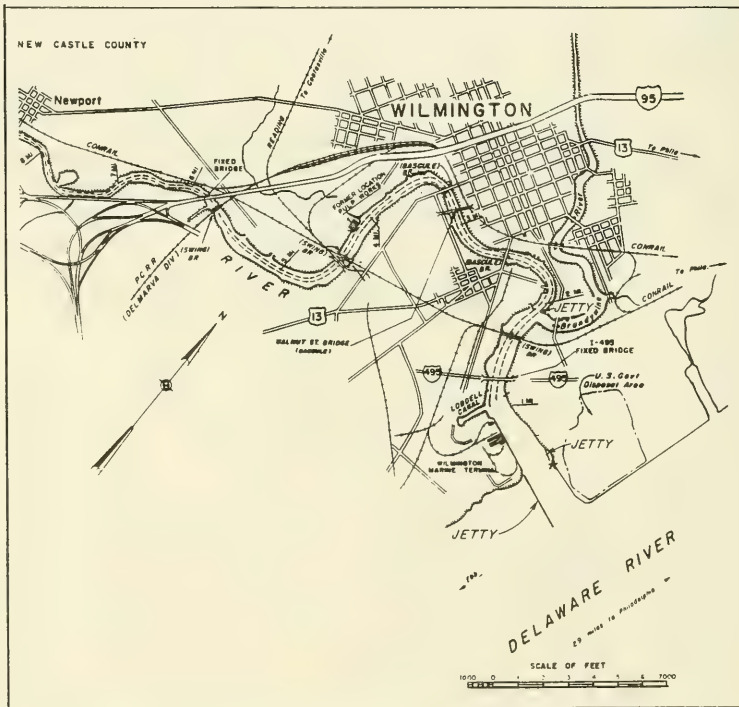
Figure 31. Wilmington Harbor, Delaware

Date(s)	Construction and Rehabilitation History
1937- 1939, 1948	Damages to the Christina south jetty, caused by ships colliding with it, were repaired each of these years at a total cost of \$90,000.
1961	The landward 500 ft of the Christina south jetty was removed to accommodate marine terminal expansion. The total length of the jetty was 1,800 ft.
1962	275 ft of buttressed steel sheet-pile wall failed during an extremely low tide and was eventually repaired.
1985	The Christina south jetty is in good condition.

1905	Repairs were made to the Brandywine River jetty and the north Christina River jetty. New wales were put on the Brandywine jetty, and face timber was replaced on the north Christina jetty. Stone was replaced where needed on both jetties.
1916	Repairs were made to the north Christina River jetty. Broken timber and piling was replaced with new material. Fender piles were placed along the channel face, and the interior of the crib was filled with stone where settling had occurred along the entire length of the jetty.
1925	The south jetty was removed, and a new jetty was to be built south of the Christina River.
1931	Approximately 1,200 ft of the north jetty was removed to improve the channel regime. The total length of the north jetty was 950 ft (Figure 31).
1936	A new jetty was completed south of the Christina River mouth. The jetty was 2,300 ft long (Figure 31) and consisted of 1,352 lin ft of steel sheet-pile wall, buttressed with 100-ft timber piles 12 ft on center, a 948-ft outboard section consisting of twelve 25.5-ft-diameter steel sheet-pile cells, and one 30.5-ft-diameter terminal cell with twelve 51-ft interconnecting fences. Crest elevation was +10 ft Corps of Engineers Datum (2.9 ft below mean sea level, 1929). The landward end of the jetty was connected to shore by a 120-ft steel sheet-pile anchor wall. The cost of construction was \$205,000.

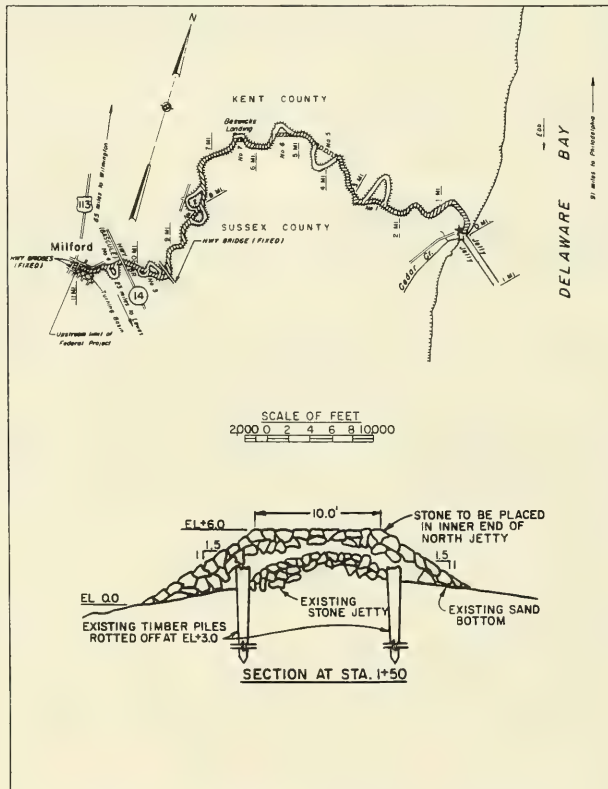
Figure 34. Mispillion River, Delaware

1944	Tops of piles were coated with tar on the north jetty near the river mouth at a cost of \$320.
1948	The north jetty was repaired beginning 708 ft from the shoreward end and extending 942 ft seaward. The original timber crib section was rehabilitated to a rubble-mound structure (Figure 34). The cost of repairs was \$51,493, and 4,870 tons of stone were used.
1963	A survey of the north jetty indicated there was no visible trace of the shoreward 708 ft. The total length of the existing jetty was 5,642 ft. The shoreward, rubble-mound, end had an average height of +6.2 ft mlw. The 1,200-ft-long timber crib structure adjacent to the rubble-mound section had deteriorated. Upper crib work was virtually nonexistent, and tops of piles were rotted or broken off. Stone had settled an average of 2.8 ft from design, was displaced, and had spilled out between piles. Piles, tie rods, and wales in the most seaward 3,500 ft appeared to be in good condition. Stone had settled an average of 1.5 ft in this section.

1964	Minor rehabilitation was done on the north jetty at a cost of \$377,848. The 1,200-ft-long deteriorated timber crib section was rehabilitated to a rubble-mound structure. The center line of the rubble-mound structure was placed north of the center line of the timber crib jetty to prevent failure of the jetty on the channel side due to lateral forces. The offset was 11.0 ft over a distance of 650 ft and 9.0 ft over a distance of 400 ft, shoreward and seaward ends of the section, respectively. Transition sections were on either end of the new structure and between the two offset sections. Crest elevation was +7.0 ft mlw, crown width was 10.0 ft, and side slopes were 1V:1.5H. Twenty-five ton minimum capstone was placed over 1- to 50-lb matstone. A layer of willow matting, compressed in

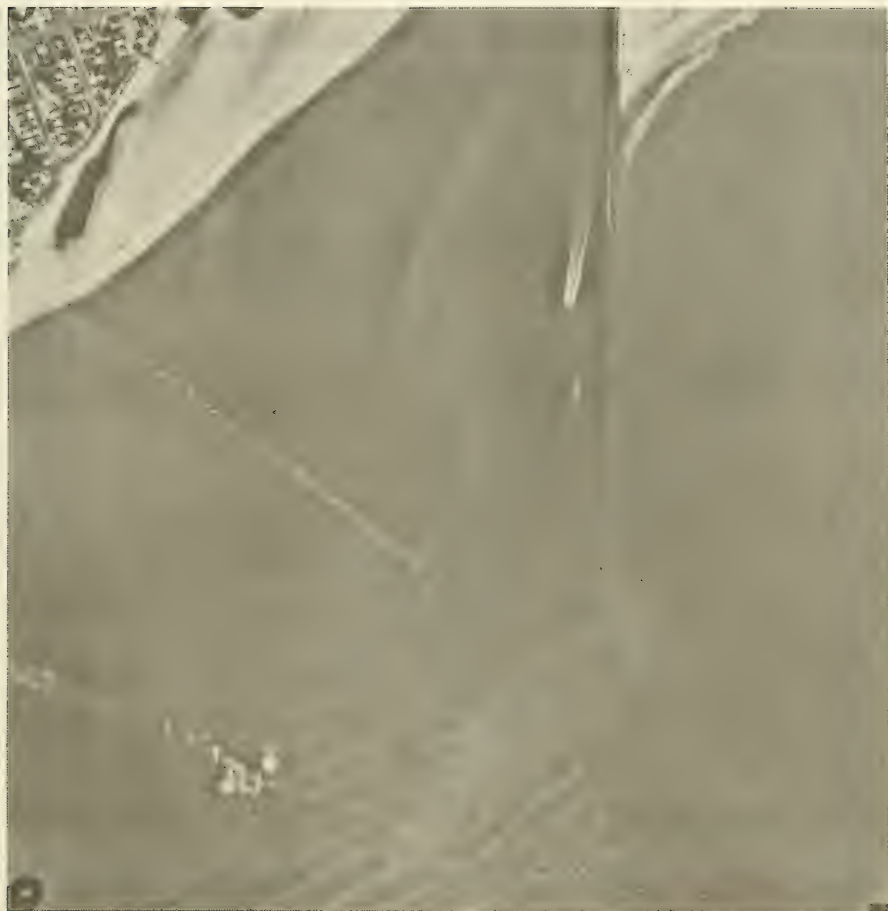
Figure 41. Photograph of Barnegat Inlet jetties

<u>Date(s)</u>	<u>Construction and Rehabilitation History</u>
1940	Two converging stone jetties were constructed north and south of the inlet for channel protection. The north jetty was 4,675 ft long, and the south jetty was 2,820 ft long (Figure 40). Design crest elevation was +2.0 ft mlw.
1944	The shoreward 100 ft of the south jetty was lowered.
1950	Repairs were made to the seaward end of the north jetty.
1954	Repairs were made to the shoreward portion of the south jetty.
1972- 1974	To prevent sand passing through and waves overtopping the north jetty, the shoreward 3,700 ft was raised to +8.0 ft mlw and made impermeable. The center line of the section repaired was offset 12.0 ft toward the inlet from the existing section (Figure 40).
1985	Due to instability and continuous shoaling of the navigation channel, proposals are being considered to construct a new south jetty. Portions of the jetties have crest elevations of +10.0 ft mlw. These sections were probably built as part of repair work conducted in 1950 and 1954. Figure 41 is an aerial photograph of the jetties in 1984.

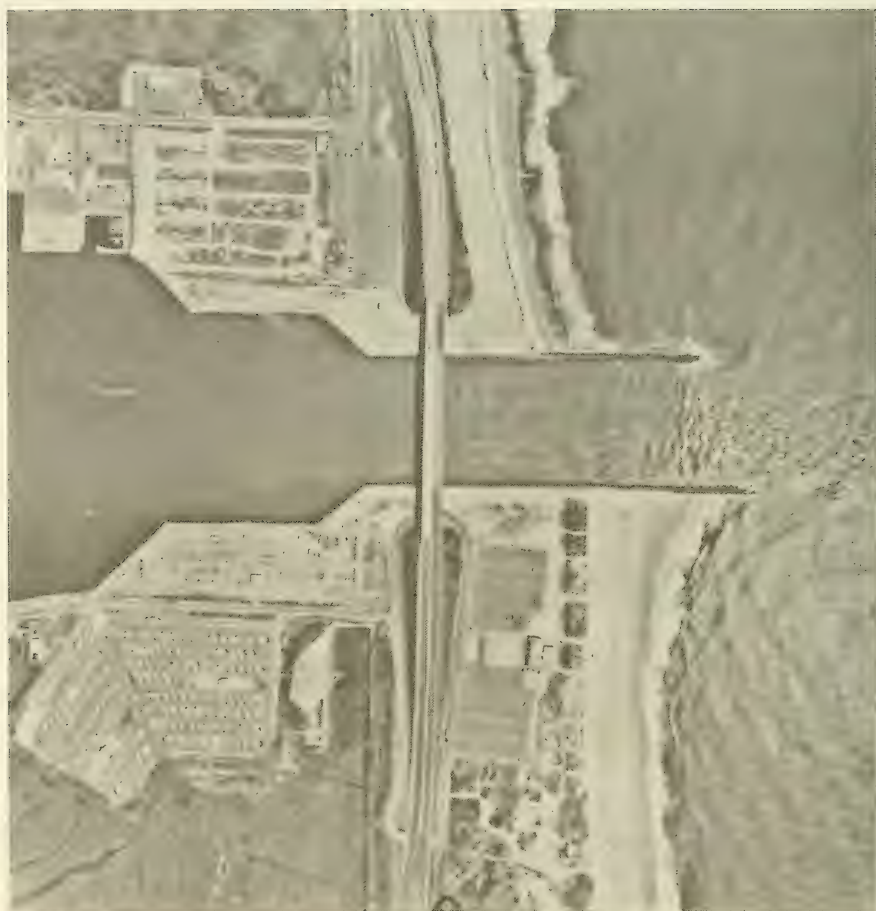
Figure 50. Photograph of Indian River Inlet jetties

<u>Date(s)</u>	<u>Construction and Rehabilitation History</u>
1939	Two parallel jetties were completed to provide inlet protection. The jetties were 1,566 ft long and 500 ft apart. The shoreward 904 ft and 890 ft of the north and south jetties, respectively, were constructed of steel sheet pile, and the seaward portions were constructed of stone. The stone jetties had a crest elevation of +6.0 ft mlw, a crown width of 10.0 ft, and side slopes of 1V:1.5H (Figure 49).
1956	Storm damages to the south jetty were repaired.
1957	The north jetty was repaired because of storm damages and was extended shoreward 320 ft because of shoreline recession and deterioration of the sheet pile (Figure 49).
1985	The jetty heads are in poor condition because of slope failure, subsidence, and toe scour. Repair alternatives have been proposed, and the use of dolosse has been suggested. Figure 50 is an aerial photograph of the jetties taken in 1985.

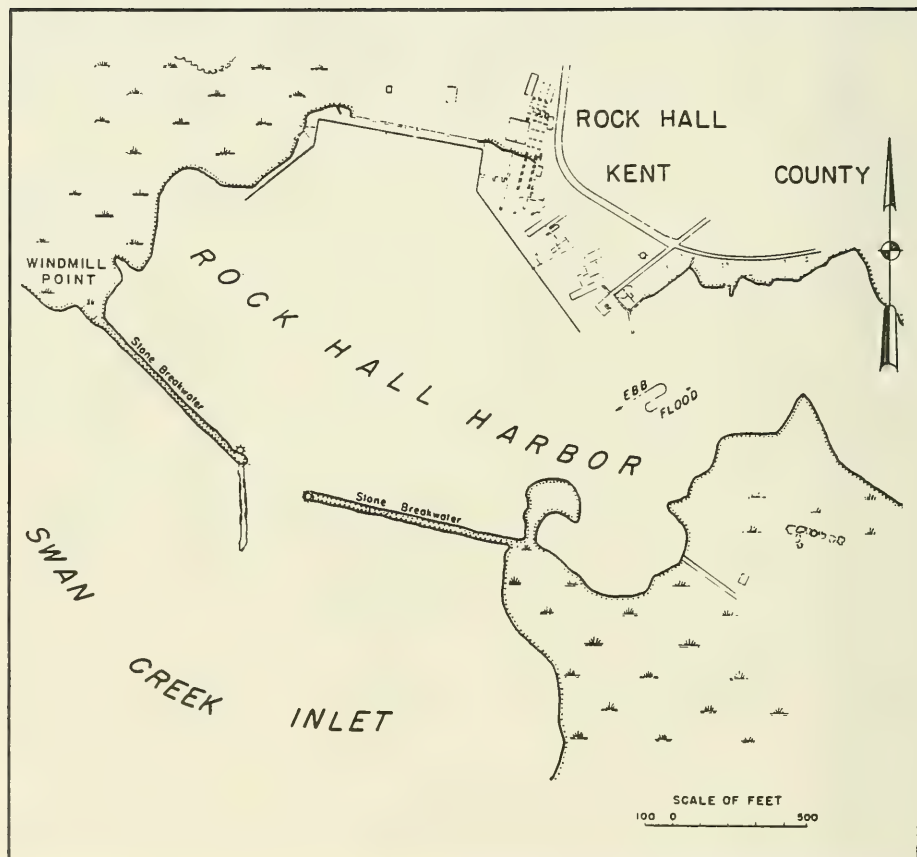
Figure 51. Rock Hall Harbor, Maryland

<u>Date(s)</u>	<u>Construction and Rehabilitation History</u>
1939	Two breakwaters were constructed with 8,400 tons of stone. Lengths of the breakwaters were 850 ft and 700 ft east and west, respectively (Figure 51). Elevations of the breakwaters were +4.0 ft mlw, with a single capstone, crown width of 4.0 ft, and side slopes of 1V:1.5H.
1964	Repairs were made on both breakwaters to restore them to original design geometry. The east breakwater was in good condition with crest subsidence of less than 0.5 ft. The majority of the repairs were made on the west breakwater. The landward 80 ft had subsided up to 2.0 ft, the seaward 50 ft had subsided to mlw, and the adjacent 380 ft had subsided 1.0 to 2.5 ft. The landward ends of both breakwaters were repaired with 250- to 500-lb stone. A 40-ft extension was added to the west breakwater (Figure 51), and the outer 220 ft, including the extension, were repaired with 1,000 to 2,000-lb cover and core stone. The adjacent 260 ft were raised by filling the existing section with additional core stone.

1982	Extensive rehabilitation was done to both breakwaters due to wave transmission and overtopping causing excessive wave heights (greater than 4.0 ft) in the inner harbor. Estimated cost of the rehabilitation was \$1,800,000 and required over 27,000 tons of stone. Crown elevation was raised to +7.0 ft mlw, crown width was widened to 8.0 ft with three capstones, and side slopes remained 1V:1.5H requiring 12,400 tons of stone. The west breakwater was extended to 1,100 ft requiring 14,800 tons of stone. Cover stone used for rehabilitation ranged from 2,300 lb at the trunk to 2,800 lb at the head. Cross sections and location of the rehabilitation are shown in Figure 52.
1986	No further repair or maintenance information has been found.

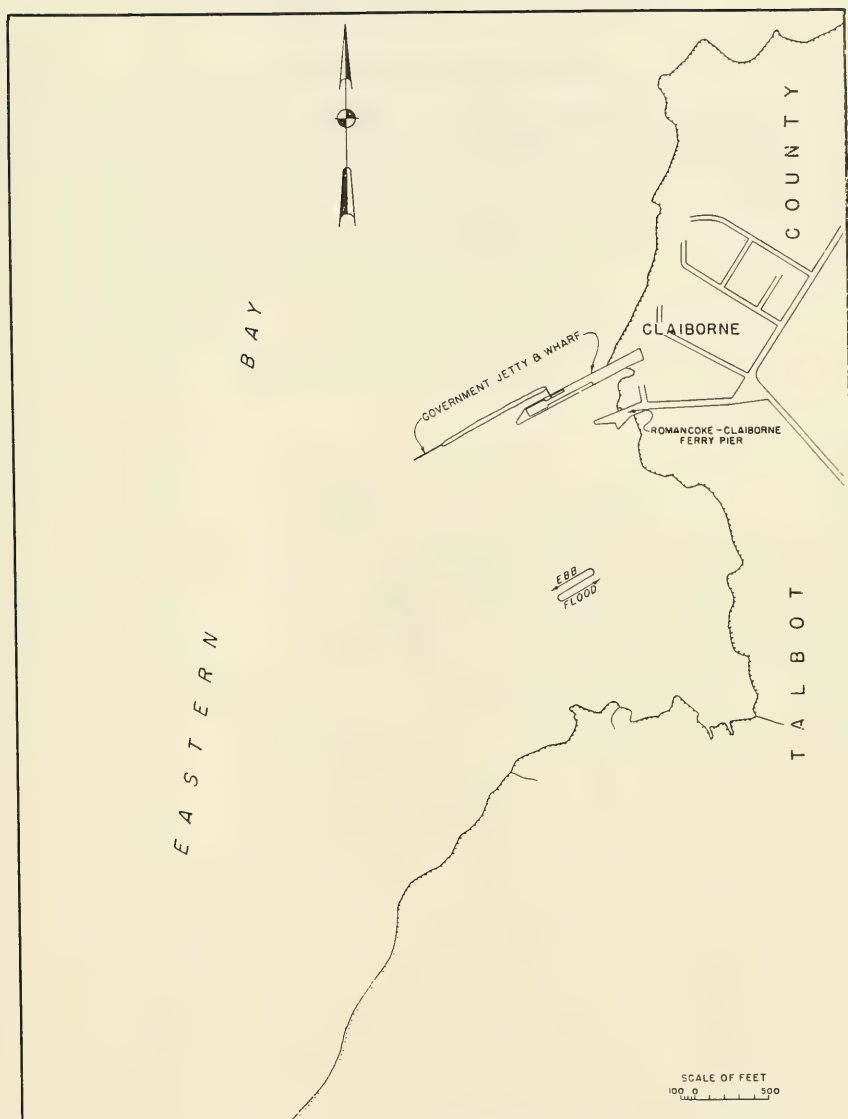
Figure 53. Claiborne Harbor, Maryland

<u>Date(s)</u>	<u>Construction and Rehabilitation History</u>
1888	A 750-ft-long slag jetty was constructed by a railway company at Claiborne Harbor.
1912	The jetty was extended 250 ft seaward as part of the federal project and was constructed of timber piles (Figure 53).
1928	The timber pile extension was in poor condition and was missing a seaward section.
1970's	The jetty was repaired, and revetment was placed around the jetty and wharf area of the harbor by non-Federal interests.
1978	A report recommended removal of deteriorated timber piles.
1981	A survey indicated the jetty was in excellent condition.
1986	Plans are complete for jetty rehabilitation. No details are available.

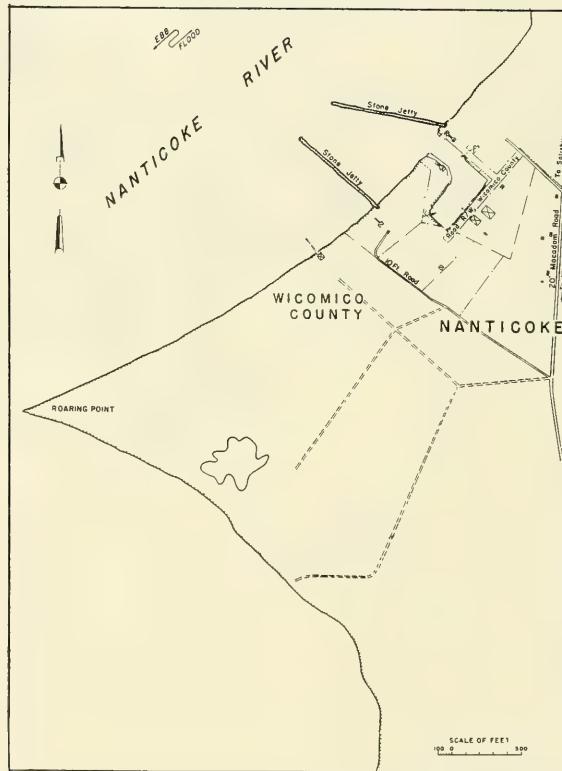
Figure 59. Nanticoke River at Nanticoke, Maryland

<u>Date(s)</u>	<u>Construction and Rehabilitation History</u>
1938	Two converging stone jetties were constructed at lengths of 850 ft and 750 ft north and south, respectively (Figure 59). Crown elevation was +5.0 ft mhw, crown width was 4.0 ft, with a single capstone, and side slopes were 1V:1.5H. A post-construction survey showed little deviation from the design elevation.
1944	A survey of the jetties indicated little change in crown elevation.
1981	A survey indicated both jetties were in excellent condition.
1986	No further repair or maintenance information has been found.

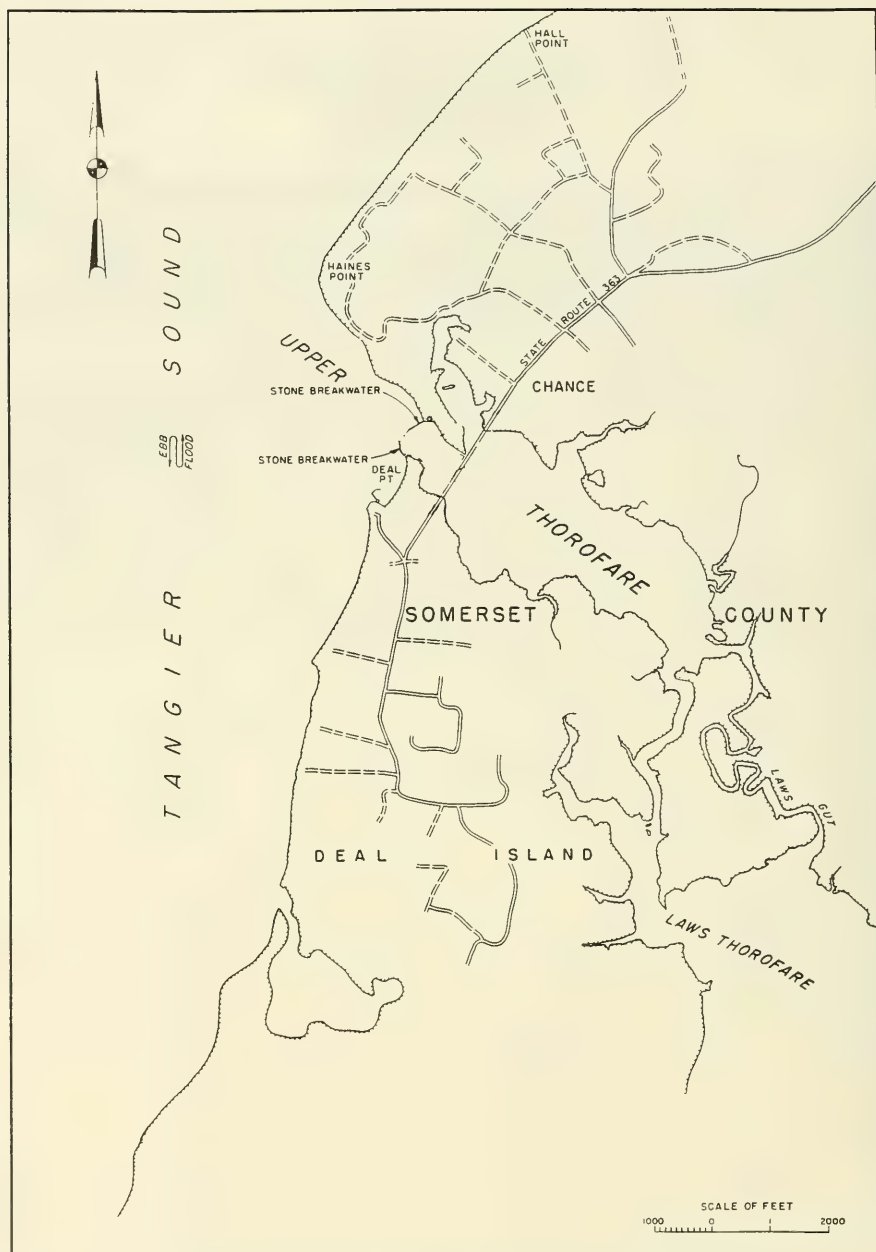
Figure 60. Upper Thorofare, Maryland

<u>Date(s)</u>	<u>Construction and Rehabilitation History</u>
1934	Two stone breakwaters were constructed with 3,650 tons of stone at an estimated cost of \$9,000. The north breakwater was 410 ft long. The south breakwater was 310 ft long. The seaward ends were 180 ft apart (Figure 60). Crest elevations were +7.0 ft mlw, except the landward 142 ft of the south breakwater which was from +5.0 to +6.5 mlw. Crown width was 4.0 ft, and side slopes were 1:1.
1966	Sand had accumulated around one-half to two-thirds of the landward end of the north breakwater. The south breakwater had an average subsidence of 2.0 ft and was repaired to raise the elevation to +7.0 ft mlw. Crown width was 4.0 ft, and side slopes were 1V:1.5H.
1981	A survey indicated the south breakwater was in excellent condition, although the midsection appeared to have subsided 1.0 ft. The north breakwater was almost completely surrounded by sand, and future shoaling of the channel was foreseen. The north breakwater appeared to have subsided 1.0 ft from the original design elevation.

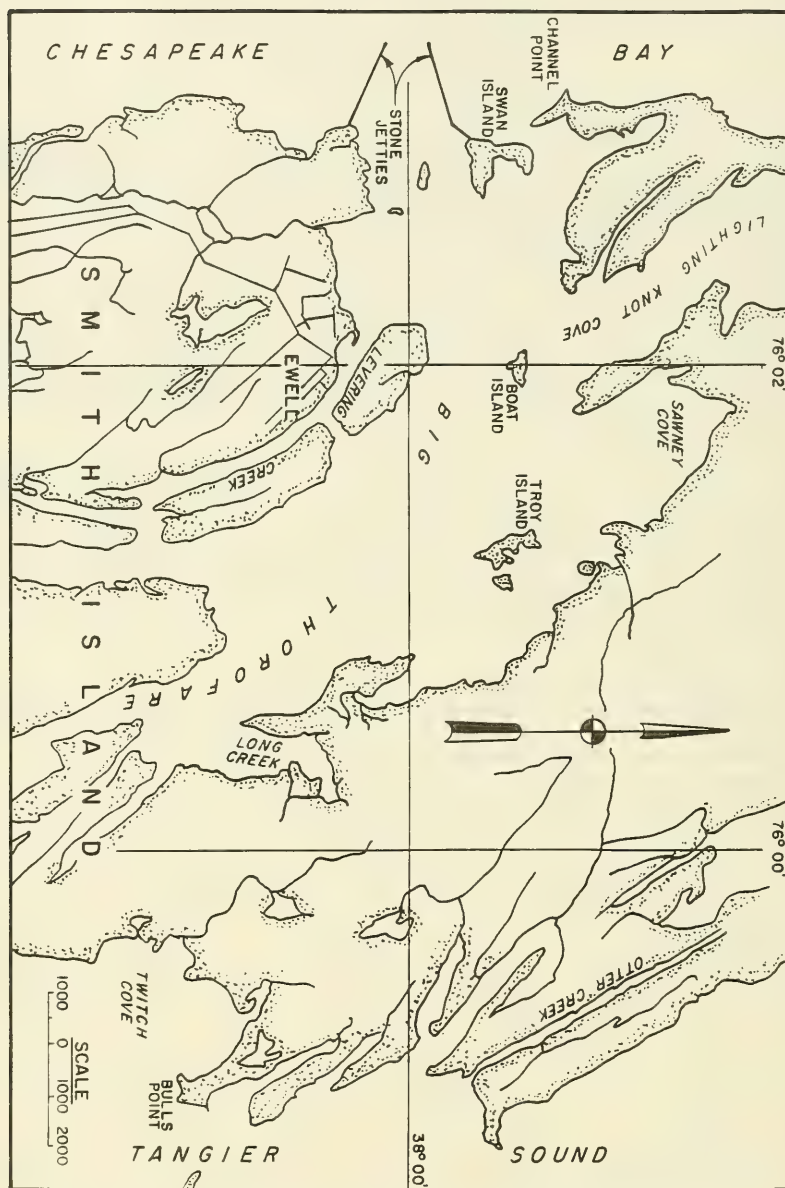
Figure 61. Twitch Cove and Big Thorofare River, Maryland

Date(s)	Construction and Rehabilitation History
1940	Two converging stone jetties were constructed with 23,000 tons of stone at a cost of \$112,000 (Figure 61). The north jetty was 2,070 ft long, and the south jetty was 1,800 ft long. The design section included a crown elevation of +4.0 ft mlw, a crown width of 2.0 ft with the exception of the seaward 120 ft of the north jetty which was 4.0 ft, and side slopes of 1V:2H, except for the bay side of the north jetty which was designed for 1:1 along the landward 1,950 ft. No stone size details were given; however, a 1981 survey indicated the side slope stone was approximately 1.5 tons, and the core was of similar stone. The survey also revealed the single cap-stone ranged from 2.0 to 3.0 tons. No apron or bedding was placed during construction or subsequent repairs.
1945	A condition survey was performed which indicated the north jetty was in a severe state of deterioration. The seaward 1,300 ft of this jetty had a typical subsidence of 0.5 ft below the original elevation, and the seaward 300 ft of this section had a range of subsidence of 2.0 to 4.0 ft. The south jetty was flanked, and the seaward 400 ft of the south jetty had subsided 0.5 to 1.5 ft. The seaward end of this section had subsided below mlw. Toe areas had scoured from -5.0 to -7.0 ft mlw.

1952	A condition survey was made on the north jetty. The seaward 570 ft had a range of subsidence from 2.0 to 5.0 ft, and 700 ft landward of this section had subsided 1.0 to 2.0 ft. Jetty cross sections indicated most of the subsidence occurred on the bay side. Repairs were made to the seaward 1,030 ft of the north jetty using original design geometry to raise the crest elevation to +3.0 ft mlw. The cost of the repairs and dredging was \$33,000.
1955- 1956	A condition survey performed on the south jetty indicated an average subsidence of 0.5 ft over the entire length. The seaward 300 ft had subsided 2.0 to 4.0 ft, and a length of 80 ft had subsided near the landward end. Areas of subsidence were typically 1.0 to 2.0 ft below adjacent sections. Repair work began in 1956 to raise the crest elevation to +3.5 ft mlw using original design geometry. Approximately 1,000 tons of stone were used at a cost of about \$35,000 which included dredging. Toe areas had scoured to -9.0 ft mlw.

1962	Both jetties were surveyed and repaired with 2,200 tons of stone for approximately \$64,500. The north jetty had been flanked on the landward end, and elevations of the seaward 520 ft ranged from +1.0 to +3.0 ft mlw. The seaward 180 ft of the south jetty had elevations ranging from 0.0 to +4.0 ft mlw. The above sections were repaired to

Date(s)	Construction and Rehabilitation History
1962 (Cont.)	a crown elevation of +4.0 ft mlw, with a 2.0-ft crown width, except the seaward 70 ft of the north jetty was 4.0 ft. The side slopes were 1V:2H. The landward end of the north jetty was extended 120 ft. Voids along the remainder of the jetties were repaired by placing and resetting existing stone at existing section elevations. The depth at the toes of the jetties ranged from 10.0 to 12.0 ft mlw.
1981	<p>A survey report indicates both jetties are in "poor" condition. The seaward end of the north jetty and the landward ends of both jetties were flanked, and there were numerous areas of subsidence along their lengths. It is believed that scour is the reason for their deterioration for the following reasons:</p> <ul style="list-style-type: none"> -- Existence of a homogeneous cross section (no smaller core placed). -- No bedding stone or apron stone being placed during original construction or during repairs. -- Increase in depth from a range of 5.0 to 6.0 ft to a range of 10.0 to 12.0 ft mlw at the seaward ends. -- Landward ends of the jetties being flanked at present. Each has been flanked once and repaired since original construction. -- General subsidence along the entire lengths of the jetties of 0.5 to 1.0 ft. -- Numerous voids or gaps where capstones were missing.

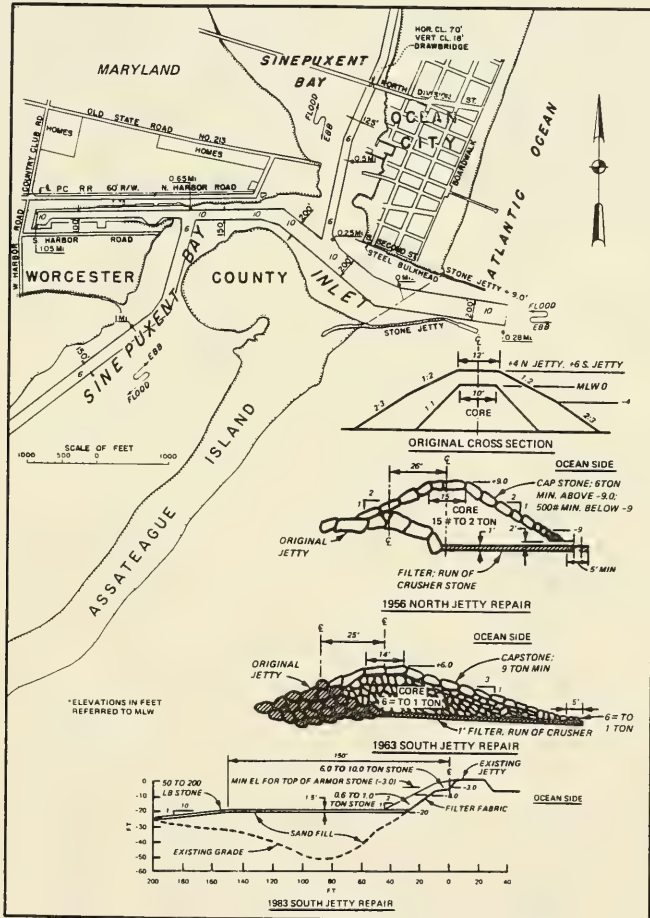
Figure 62. Ocean City Inlet, Maryland

Date(s)	Construction and Rehabilitation History
1934	A 1,100-ft-long jetty was constructed on the north side of a newly formed inlet at Ocean City (Figure 62). Crest elevation was +4.0 mlw, crown width was 12.0 ft, and side slopes were 1V:2H from the crest to -4.0 mlw and 1V:1.5H from -4.0 mlw to the bottom.
1935	Construction was completed on a jetty on the south side of the inlet. Crest elevation was +6.0 ft mlw, and crown width was 12.0 ft. The landward 750 ft of the jetty was 1,100 ft south of the north jetty. The south jetty angled north 1,100 ft to a point 600 ft from the north jetty. The final 530 ft of the south jetty was parallel to that of the north jetty. The crest elevation decreased from +6.0 ft mlw to the apron elevation beginning 170 ft seaward of this final section. The apron extended 200 ft farther seaward. The total length of the jetty was 2,380 ft, including the apron. A total of 39,500 tons of stone was used for core; 17,300 tons were used for capstone on the south jetty.

1937	Sand on the north side of the north jetty had reached the top of the jetty and was depositing in the inlet. A concrete superstructure was built to raise the jetty elevation. The first 100 ft from the boardwalk was raised to +12.0 ft mlw, the next 254 ft was raised to +9.0 ft, and the next 170 ft was raised to +7.0 ft mlw.
1956	Repairs were made on the seaward 750 ft of the north jetty because of slope failures on the channel side from toe scour. The existing concrete cap was repaired and raised to +9.0 ft. Armor stone was placed on the seaward 575 ft. The armor stone section was placed 26 ft north of the center line to use existing stone as toe protection and to minimize the stone required. The landward end of the south jetty was repaired to maintain integrity with the shoreline.
1963	Approximately 720 ft of the south jetty was rehabilitated due to slope failures caused by a scour hole that had an elevation of -37 ft mlw. Armor stone was placed 25 ft seaward of the center line for the same reasons stated above in positioning the north jetty. The landward end of the south jetty was again repaired to maintain integrity with the shoreline.

1984	The seaward 1,100 ft of the south jetty was rehabilitated due to slope failures. The section repaired in 1963 had deteriorated. The scour hole had a maximum depth of -54 ft mlw. Repairs consisted of filling the scour hole with dredged material to -20 ft mlw, covering the hole with 18 in. of blanket stone, and placing stone berm quarry run and armor stone along the toe on the channel side of the

Date(s)	Construction and Rehabilitation History
1984 (Cont.)	existing jetty. The landward end of the south jetty was sand tight-ened to prevent material from passing through the jetty and shoaling into the channel. Three rubble mound breakwaters were constructed landward of the jetty to prevent expected erosion from occurring as a result of sand tightening.
1986	No further repair or maintenance information has been found.

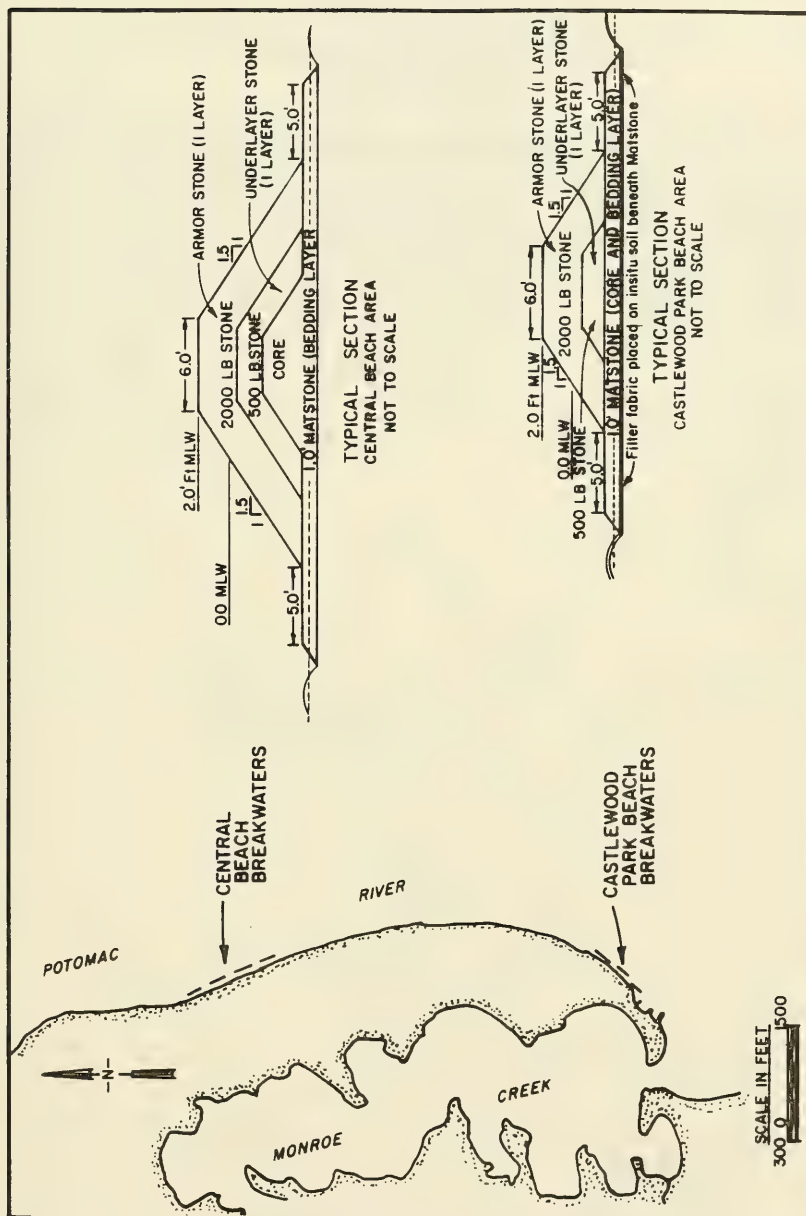
Figure 63. Colonial Beach, Virginia

<u>Date(s)</u>	<u>Construction and Rehabilitation History</u>
1982	Seven offshore breakwaters were constructed as part of a beach restoration project for approximately \$447,000, using over 9,000 tons of stone (Figure 63). One 300-ft breakwater and two 200-ft breakwaters were placed at Castlewood Beach, and four 200-ft breakwaters were placed at Central Beach. All were placed parallel to the shoreline and approximately 100 ft offshore, and they were separated by 150-ft gaps. Crest elevations were +3.0 ft mlw but allowed for settlement to +2.0 ft mlw. Crown widths were 6.0 ft, and side slopes were 1V:1.5H. One layer of 2,000-lb cover stone was placed over one layer of 500-lb underlayer resting on a core and 1 ft bedding layer. Design wave height was 6.0 ft.
1985	The breakwaters are in excellent condition and serving their intended function.

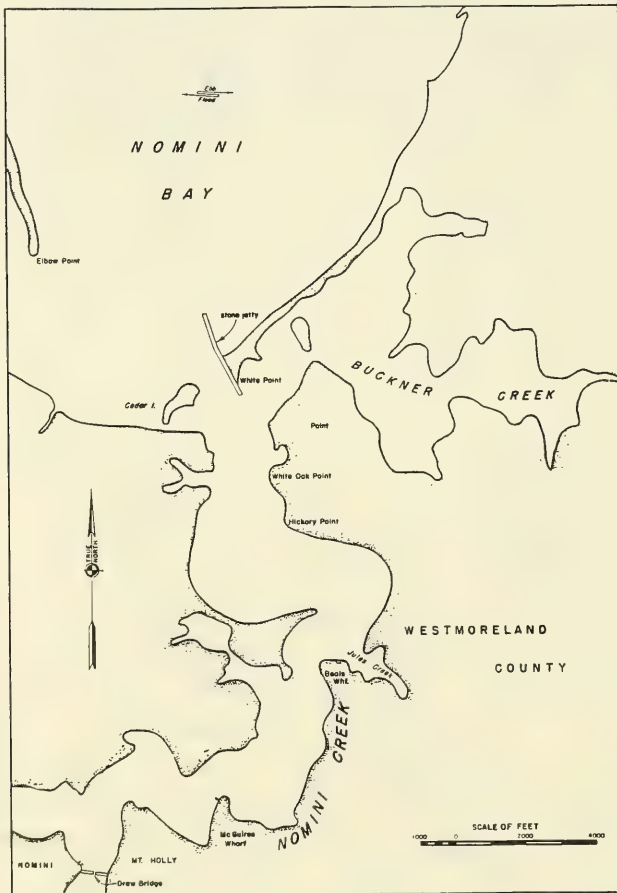
Figure 64. Nomini Bay and Creek, Virginia

<u>Date(s)</u>	<u>Construction and Rehabilitation History</u>
1912	A 2,410-ft-long stone jetty was completed (Figure 64).
1981	A survey indicated the jetty was in good condition.
1986	No further repair or maintenance information has been found.

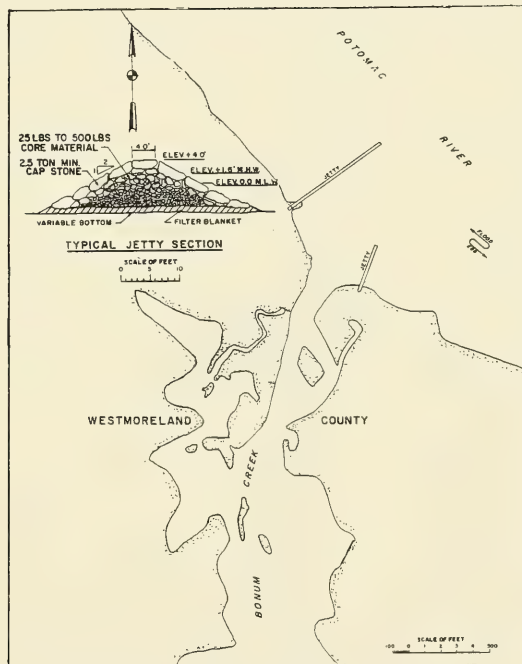
Figure 65. Bonum Creek, Virginia

<u>Date(s)</u>	<u>Construction and Rehabilitation History</u>
1968	Construction was completed on two stone jetties at an estimated cost of \$221,000 using 8,000 tons of stone. The north jetty was 800 ft long, and the south jetty was 300 ft long (Figure 65). Crown elevation was +4.0 ft mlw, crown width was 4.0 ft with a single capstone, and side slopes were 1V:2H. Cover stone used was 2.5 tons, and core stone ranged from 25 to 500 lb. Design wave height was 9.0 ft.
1981	A condition survey revealed that the jetties had undergone some settlement but were in good condition.
1986	No further repair or maintenance information has been found.

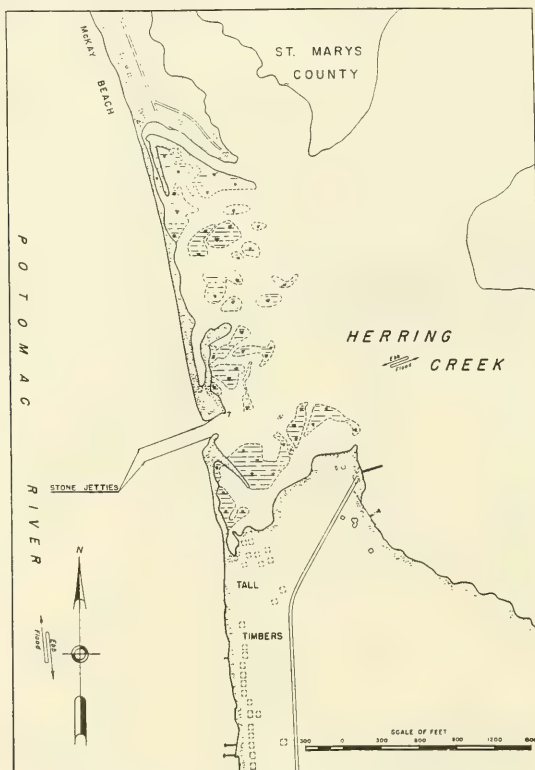
Figure 66. Herring Creek, Maryland

<u>Date(s)</u>	<u>Construction and Rehabilitation History</u>
1960- 1961	Two jetties were constructed to 750- and 700-ft lengths north and south, respectively (Figure 66). Crown elevation was +4.5 ft mlw, crown width was 4.0 ft, and side slopes were 1V:2.5H. A 1.0-ft-thick bedding layer was placed, and a 1.0-ft-thick by 10.0-ft-wide apron was placed along both jetty toes.
1981	A survey indicated the jetties were in good condition with only minor settlement.
1986	No further repair or maintenance information has been found.
